**DEPARTMENT OF TRANSPORTATION**

Quality Assurance and Source Inspection

## WELDING INSPECTION REPORT

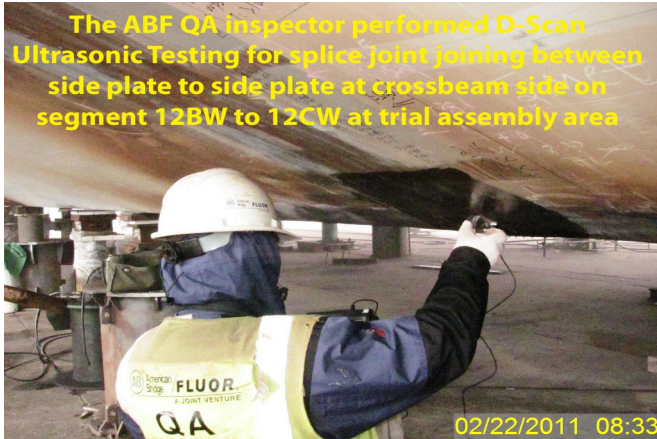
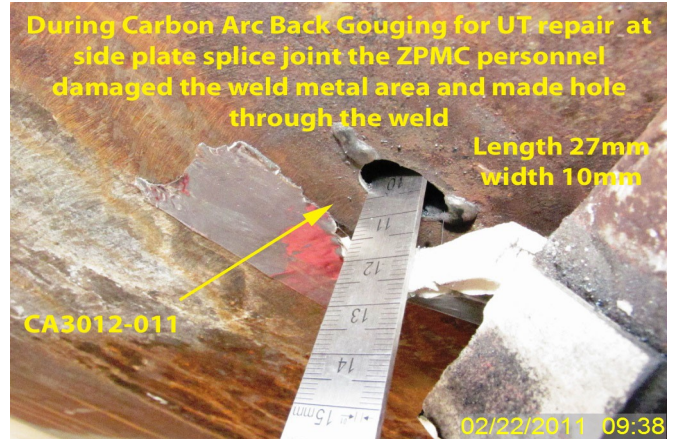
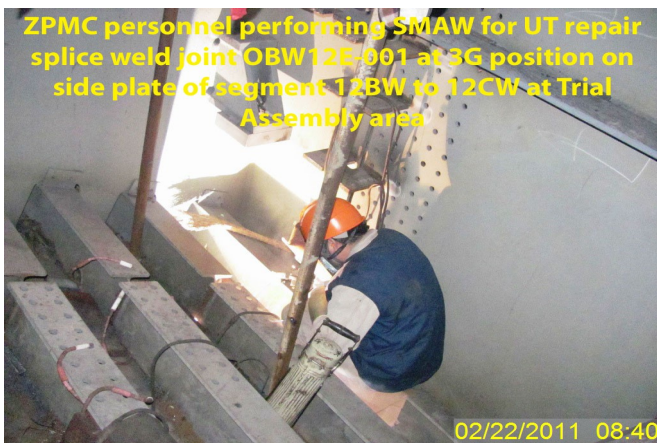
During random QA verification the QA inspector observed that the ZPMC personnel damaged the weld metal during Carbon Arc Back Gouging of UT repair location at splice joint of side plate of segment 12BW to 12CW at counter weight side. The ZPMC personnel made through hole on the weld. This QA inspector notified to ZPMC QC and ABF QA regarding this through hole on the weld. For more information refer the attached photo.
